# Appendix 10.1

## Watercourse Crossing Assessment

- A10.1.1. This technical appendix (**Appendix 10.1**) presents the Watercourse Crossing Assessment in support of **Volume 1, Chapter 10: Hydrology, Geology, Hydrogeology and Peat** of the Environmental Impact Assessment (EIA) Report for Deucheran Hill 2 Wind Farm (the Proposed Development).

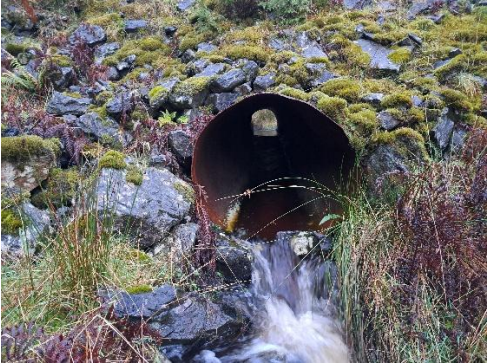
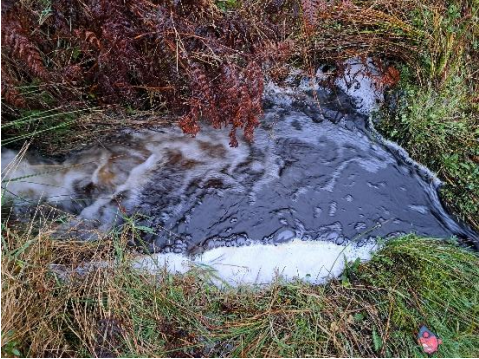
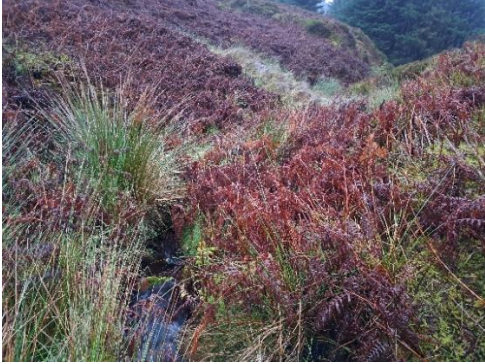
| WX3 (174975, 644372) | | |
|---|---|--|
| | <p><b>Existing Crossing:</b> Yes</p> <p><b>Crossing Type (existing):</b> Circular Culvert</p> <p><b>Crossing Material (existing):</b> Corrugated sheet metal</p> <p><b>Crossing Condition (existing):</b> Good</p> <p><b>Channel Type:</b> Incised</p> <p><b>Gradient:</b> Steep</p> <p><b>Valley form:</b> Deep Vee</p> <p><b>Bank condition:</b> Stable</p> <p><b>Bed material:</b> Coarse gravel, Boulders, Rounded pebbles</p> <p><b>Riparian corridor:</b> Commercial forestry</p> <p><b>Flow condition:</b> Very Fast</p> <p><b>Culvert Dimensions (m):</b></p> <ul style="list-style-type: none"><li>- Height (m): 1.30</li><li>- Outside Width (m): 1.30</li><li><b>Water width (m):</b> 0.50</li><li><b>Water depth (m):</b> 0.40</li><li><b>Bankfull width (m):</b> 0.50</li><li><b>Bankfull height (m):</b> 0.45</li><li><b>Banktop height (m):</b> 0.60</li><li><b>Flooded Bankfull width (m):</b> 1.20</li><li><b>Flooded Bankfull height:</b> 0.60</li></ul> <p><b>Note:</b> None</p> | |

| ID | Easting | Northing | Existing Crossing? | Potential Crossing Type and Considerations | Potential EASR Authorisation Level |
|---|---|---|---|---|---|
| WX3 | 174975 | 644372 | Yes; existing circular culvert | Maintain if possible. If track/embankment require significant works, consider replacement with an oversized embedded culvert or bottomless arch culvert. | Registration |

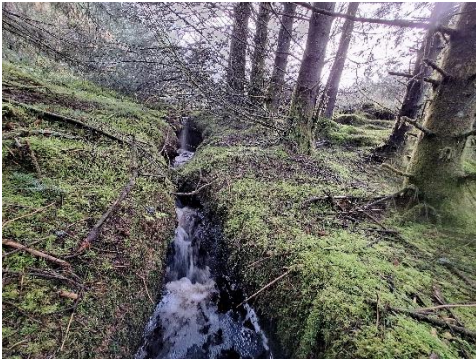
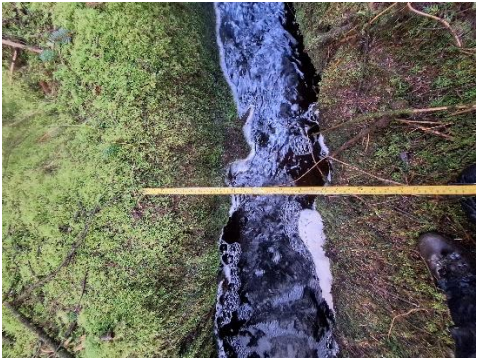
WX5 (175498, 643679)

**Bank condition:** Undercut (no evidence of recent collapse)

**Flow condition:** Fast

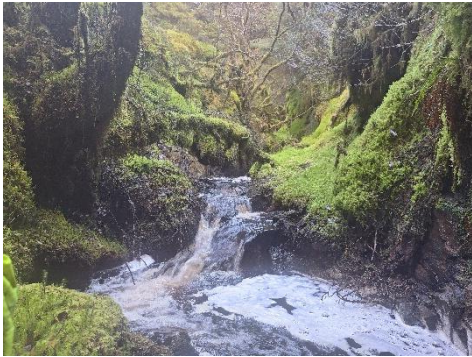
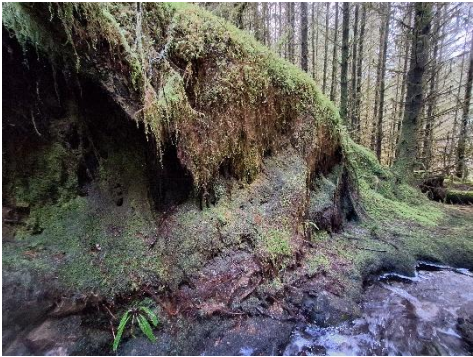
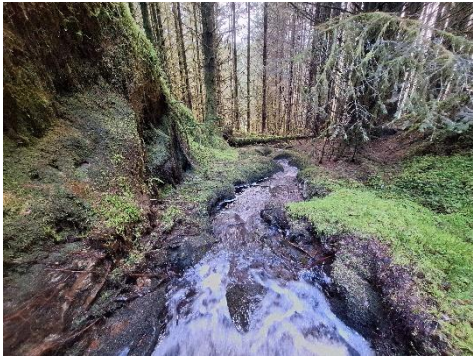
| <b>Flow condition:</b> Fast | <b>Note:</b> A very tall bank is present at this location, with pools forming at the base as a result of the upstream waterfall. |

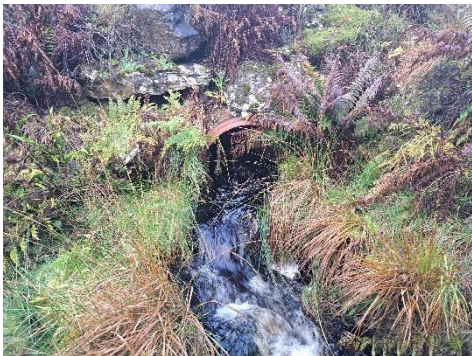
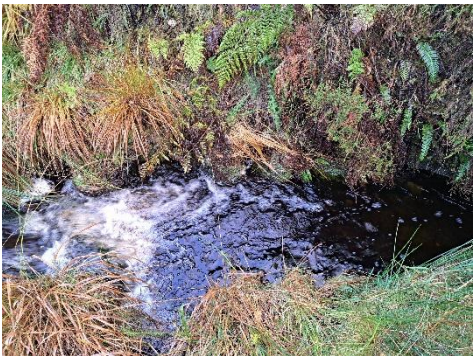
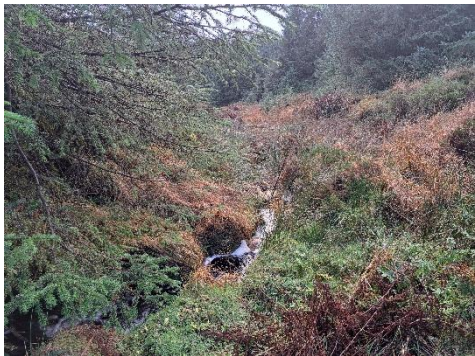
WX10 (176259, 643629)

- Existing Crossing:** Yes
- Crossing Type (existing):** Circular Culvert
- Crossing Material (existing):** Corrugated sheet metal
- Crossing Condition (existing):** Average
- Channel Type:** Incised
- Gradient:** Moderate
- Valley form:** Shallow Vee
- Bank condition:** Undercut (no evidence of recent collapse)
- Bed material:** Fine sand/silt, Rounded pebbles, Coarse gravel, Boulders
- Riparian corridor:** Commercial forestry
- Flow condition:** Fast
- Culvert Dimensions (m):**
- Height (m): 0.80
  - Outside Width (m): 0.80
- Water width (m):** 0.70
- Water depth (m):** 0.20
- Bankfull width (m):** 0.70
- Bankfull height (m):** 0.30
- Banktop height (m):** 0.60
- Flooded Bankfull width (m):** 1.00
- Flooded Bankfull height:** 0.55
- Note:** None

| ID | Easting | Northing | Existing Crossing? | Potential Crossing Type and Considerations | Potential EASR Authorisation Level |
|---|---|---|---|---|---|
| WX10 | 176259 | 643629 | Yes; existing circular culvert | Maintain if possible. If track/embankment require significant works, consider replacement with an oversized embedded culvert or bottomless arch culvert. | Registration |

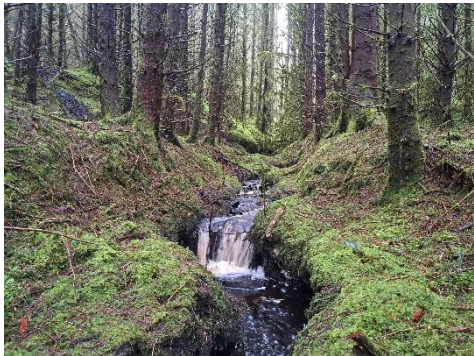
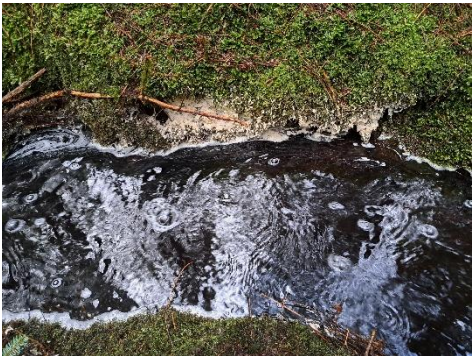
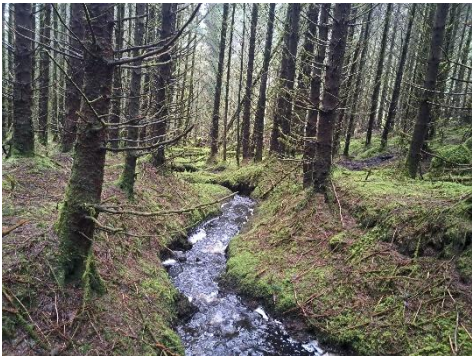
**Bank condition:** Undercut (no evidence of recent collapse)

**Note:** Multiple surface runoff channels were observed entering the stream.

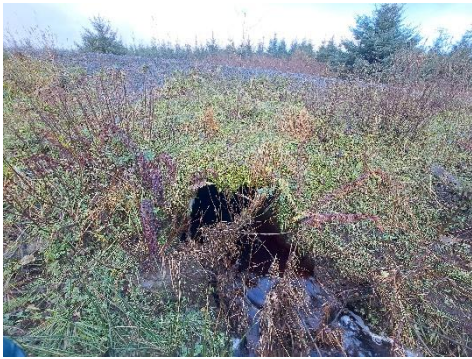
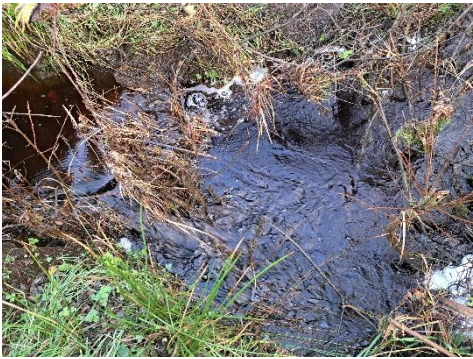
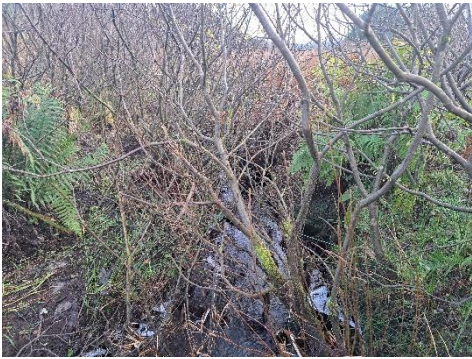
| WX12 (176309, 643372) | | |
|---|---|--|
| <p>Legend:</p> <ul style="list-style-type: none"><li>Watercourse crossing location</li><li>Watercourse</li><li>50m watercourse buffer</li><li>Proposed HGV track</li><li>Proposed New track</li><li>Proposed borrow pit</li><li>Proposed substation</li><li>Proposed Turbine Hardstandings</li><li>Proposed Turbine locations</li></ul> <p>© Crown Copyright 2025. All rights reserved. Ordnance Survey Licence 0100031673.</p> | <p><b>Existing Crossing:</b> Yes</p> <p><b>Crossing Type (existing):</b> Circular Culvert</p> <p><b>Crossing Material (existing):</b> Corrugated sheet metal</p> <p><b>Crossing Condition (existing):</b> Poor</p> <p><b>Channel Type:</b> Incised</p> <p><b>Gradient:</b> Gentle</p> <p><b>Valley form:</b> No obvious valley sides</p> <p><b>Bank condition:</b> Undercut (no evidence of recent collapse)</p> <p><b>Bed material:</b> Fine sand/silt, Rounded pebbles, Coarse gravel, Boulders</p> <p><b>Riparian corridor:</b> Commercial forestry</p> <p><b>Flow condition:</b> Moderate</p> <p><b>Culvert Dimensions (m):</b></p> <ul style="list-style-type: none"><li>- Height (m): 1.10</li><li>- Outside Width (m): 1.10</li></ul> <p><b>Water width (m):</b> 1.30</p> <p><b>Water depth (m):</b> 0.45</p> <p><b>Bankfull width (m):</b> 1.30</p> <p><b>Bankfull height (m):</b> 0.45</p> <p><b>Banktop height (m):</b> 0.55</p> <p><b>Flooded Bankfull width (m):</b> 1.80</p> <p><b>Flooded Bankfull height:</b> 0.55</p> <p><b>Note:</b> None</p> | |

| ID | Easting | Northing | Existing Crossing? | Potential Crossing Type and Considerations | Potential EASR Authorisation Level |
|---|---|---|---|---|---|
| WX12 | 176309 | 643372 | Yes; existing circular culvert | If track/embankment require significant works, consider replacement with an oversized embedded culvert, a bottomless arch culvert or a clear-span bridge. | Registration |

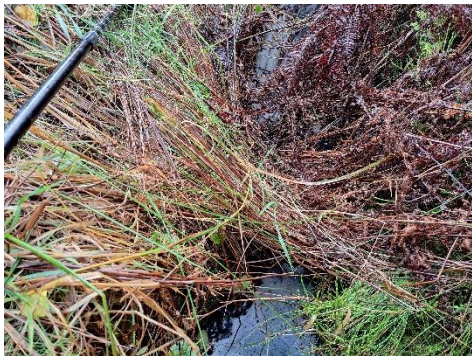
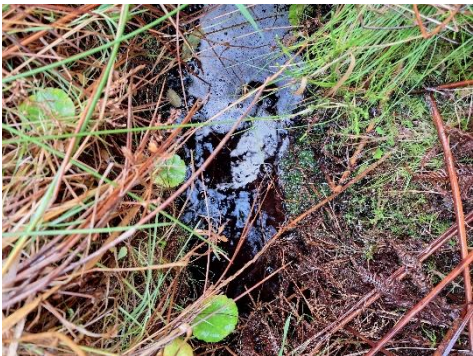
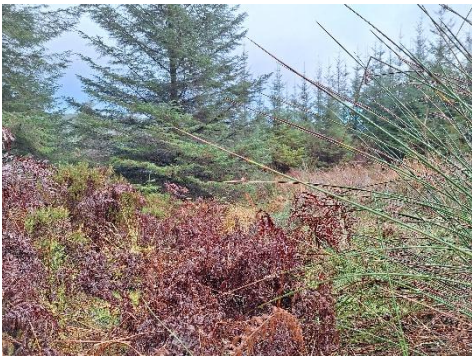
**Existing Crossing:** No  
**Channel Type:** Incised  
**Gradient:** Steep  
**Valley form:** No obvious valley sides  
**Bank condition:** Stable  
**Bed material:** Boulders, Vegetation, Rounded pebbles, Soil  
**Riparian corridor:** Commercial forestry  
**Flow condition:** Moderate

**Water width (m):** 0.28  
**Water depth (m):** 0.22  
**Bankfull width (m):** 0.32  
**Bankfull height (m):** 0.22  
**Banktop height (m):** 0.28  
**Flooded Bankfull width (m):** 0.38  
**Flooded Bankfull height:** 0.28  
**Note:** The channel is largely obscured by dense fern cover. A steep waterfall is located upstream of the water-crossing point, creating a small pool at its base.

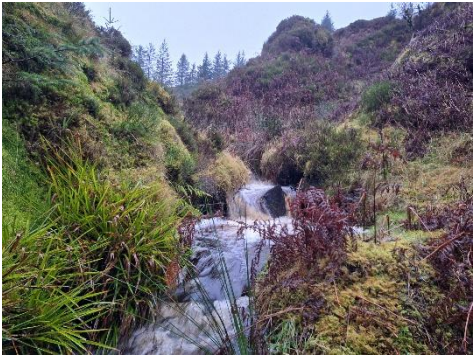
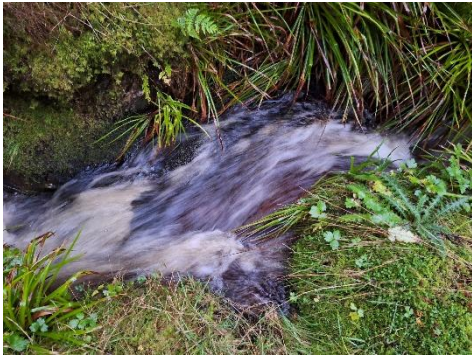
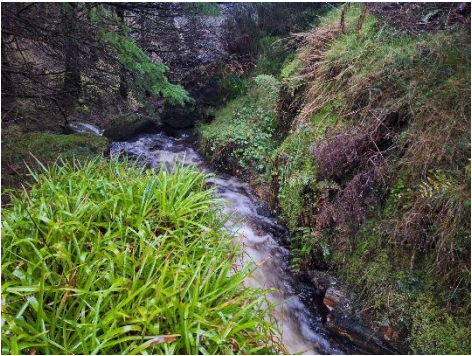
**Channel Type:** Incised  
**Gradient:** Steep  
**Valley form:** Deep Vee  
**Bank condition:** Stable  
**Bed material:** Rounded pebbles, Boulders, Coarse gravel, Vegetation  
**Riparian corridor:** Commercial forestry  
**Flow condition:** Very Fast

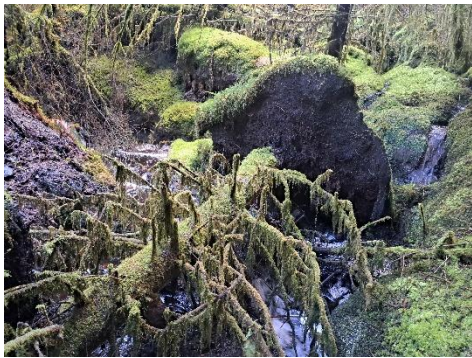
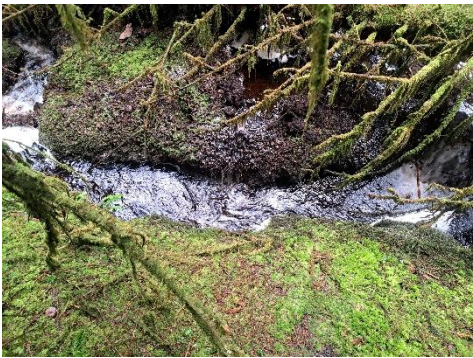
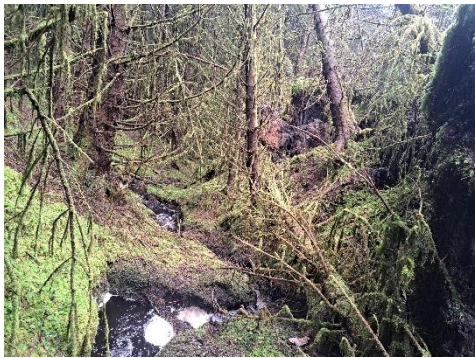
**Channel Type:** Incised  
**Gradient:** Steep  
**Valley form:** Gorge  
**Bank condition:** Unstable (potential recent collapse)  
**Bed material:** Coarse gravel, Rounded pebbles, Fine sand/silt, Peat  
**Riparian corridor:** Commercial forestry  
**Flow condition:** Fast

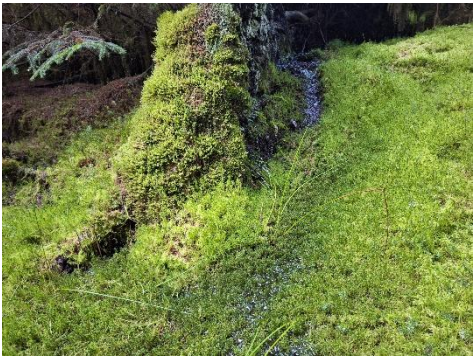
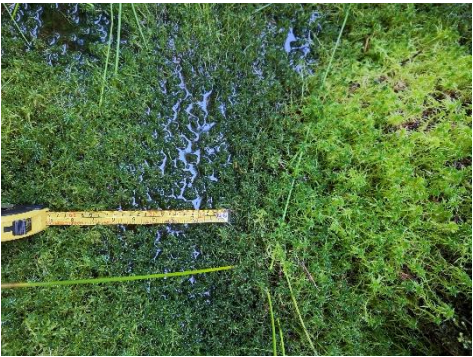
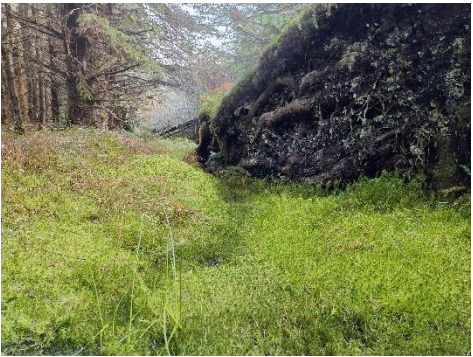
| IN8 (176360, 645435) | | |

| IN8 (176360, 645435) | | |
|---|---|---|
| | <b>Channel Type:</b> Surface run-off/wetlands only | |
