# Appendix 10.1

## Watercourse Crossing Assessment

- A10.1.1. This technical appendix (**Appendix 10.1**) presents the Watercourse Crossing Assessment in support of **Volume 1, Chapter 10: Hydrology, Geology, Hydrogeology and Peat** of the Environmental Impact Assessment (EIA) Report for Deucheran Hill 2 Wind Farm (the Proposed Development).

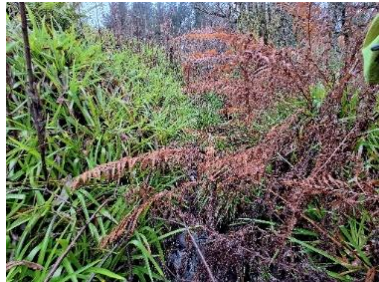
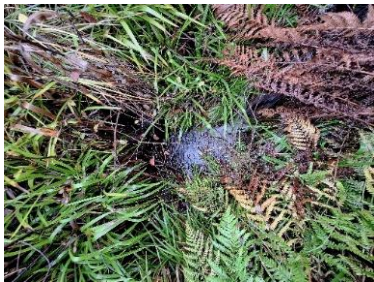
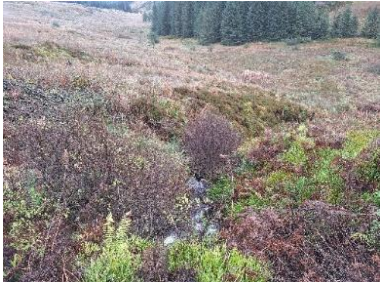
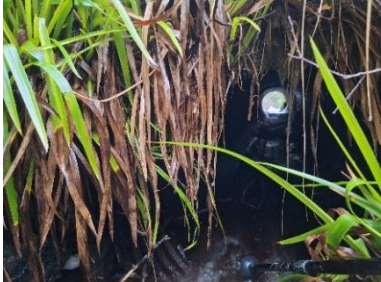
| WX1 (174798, 643616) | | |
|---|---|--|
| | <p><b>Existing Crossing:</b> Yes</p> <p><b>Crossing Type (existing):</b> Circular Culvert</p> <p><b>Crossing Material (existing):</b> Plastic</p> <p><b>Crossing Condition (existing):</b> Good</p> <p><b>Channel Type:</b> Incised</p> <p><b>Gradient:</b> Steep</p> <p><b>Valley form:</b> Deep Vee</p> <p><b>Bank condition:</b> Undercut (no evidence of recent collapse)</p> <p><b>Bed material:</b> Boulders, Coarse gravel, Vegetation, Rounded pebbles</p> <p><b>Riparian corridor:</b> Commercial forestry</p> <p><b>Flow condition:</b> Fast</p> <p><b>Culvert Dimensions (m):</b></p> <ul style="list-style-type: none"><li>- Height (m): 0.70</li><li>- Outside Width (m): 0.70</li></ul> <p><b>Water width (m):</b> 0.57</p> <p><b>Water depth (m):</b> 0.28</p> <p><b>Bankfull width (m):</b> 0.57</p> <p><b>Bankfull height (m):</b> 0.28</p> <p><b>Banktop height (m):</b> 0.75</p> <p><b>Flooded Bankfull width (m):</b> 0.85</p> <p><b>Flooded Bankfull height:</b> 0.35</p> <p><b>Note:</b> The existing crossing is in good condition. Measurement of the culvert dimensions was constrained by dense vegetation and high flow velocity at the time of survey.</p> | |

| ID | Easting | Northing | Existing Crossing? | Potential Crossing Type and Considerations | Potential EASR Authorisation Level |
|---|---|---|---|---|---|
| WX1 | 174798 | 643616 | Yes; existing circular culvert | Maintain if possible. If track/embankment require significant works, consider replacement with an oversized embedded culvert or bottomless arch culvert. | Registration |

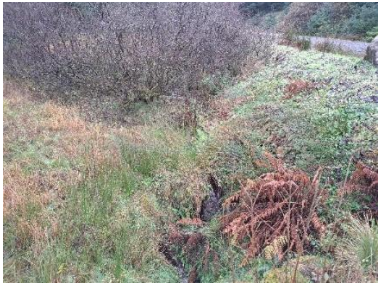
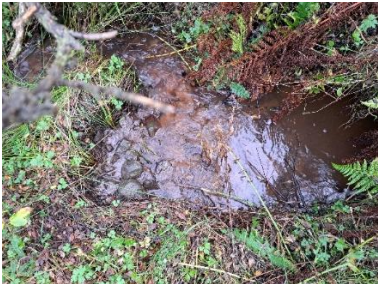
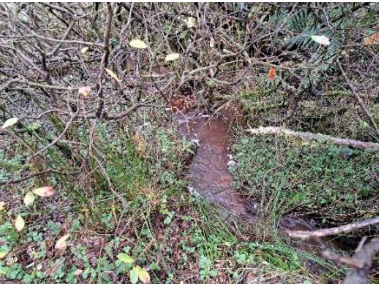
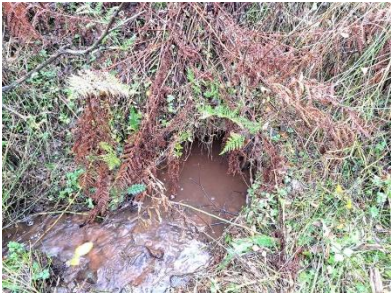
| WX2 (174823, 643378) | | |
|---|---|--|
| | <p><b>Existing Crossing:</b> Yes</p> <p><b>Crossing Type (existing):</b> Circular Culvert</p> <p><b>Crossing Material (existing):</b> Corrugated sheet metal</p> <p><b>Crossing Condition (existing):</b> Poor</p> <p><b>Channel Type:</b> Incised</p> <p><b>Gradient:</b> Moderate</p> <p><b>Valley form:</b> U-shaped valley</p> <p><b>Bank condition:</b> Undercut (no evidence of recent collapse)</p> <p><b>Bed material:</b> Rounded pebbles, Fine sand/silt, Vegetation</p> <p><b>Riparian corridor:</b> Commercial forestry</p> <p><b>Flow condition:</b> Moderate</p> <p><b>Culvert Dimensions (m):</b></p> <ul style="list-style-type: none"><li>- Height (m): 0.60</li><li>- Outside Width (m): 0.60</li></ul> <p><b>Water width (m):</b> 0.60</p> <p><b>Water depth (m):</b> 0.10</p> <p><b>Bankfull width (m):</b> 0.60</p> <p><b>Bankfull height (m):</b> 0.10</p> <p><b>Banktop height (m):</b> 0.25</p> <p><b>Flooded Bankfull width (m):</b> 0.80</p> <p><b>Flooded Bankfull height:</b> 0.25</p> <p><b>Note:</b> None</p> | |

| ID | Easting | Northing | Existing Crossing? | Potential Crossing Type and Considerations | Potential EASR Authorisation Level |
|---|---|---|---|---|---|
| WX2 | 174823 | 643378 | Yes; existing circular culvert | Culvert in poor condition. If track/embankment require significant works, consider replacement with an oversized embedded culvert or bottomless arch culvert. | Registration |

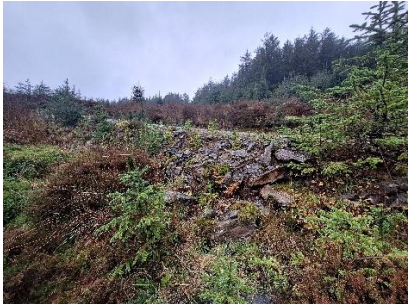
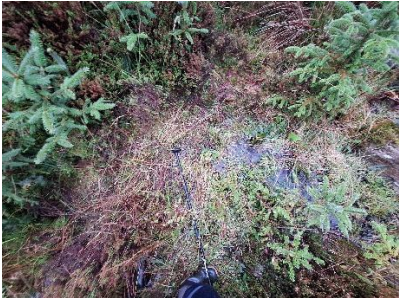
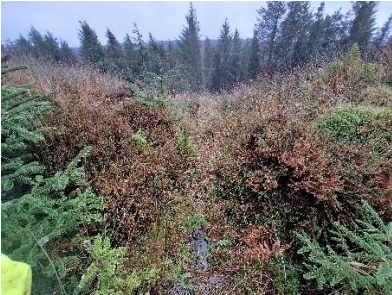
| WX4 (175321, 644641) | | |
|---|---|---|
| | <b>Channel Type:</b> Surface run-off/wetlands only | <b>Water width (m):</b> 0.25 |
| | <b>Bank condition:</b> Stable | <b>Bankfull height (m):</b> 0.10 |
| | <b>Flow condition:</b> Moderate | <b>Flooded Bankfull height:</b> 0.20 |

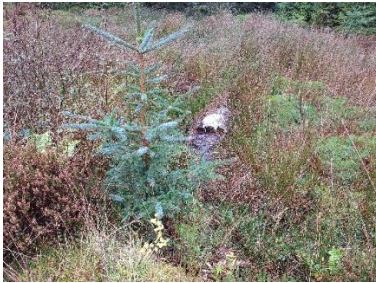
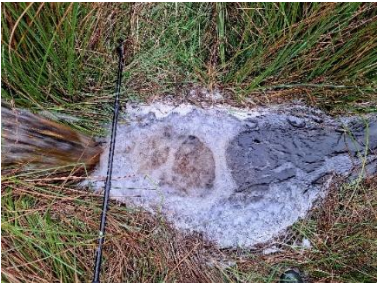
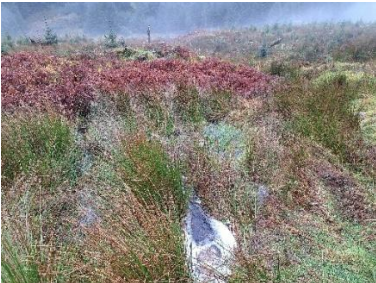
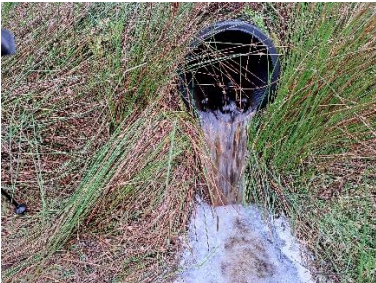
| WX6 (175580, 644851) | | |
|---|---|--|
| <p>© Crown Copyright 2025. All rights reserved. Ordnance Survey Licence 0100031673.</p> | <p><b>Existing Crossing:</b> Yes</p> <p><b>Crossing Type (existing):</b> Circular Culvert</p> <p><b>Crossing Material (existing):</b> Plastic</p> <p><b>Crossing Condition (existing):</b> Good</p> <p><b>Channel Type:</b> Incised</p> <p><b>Gradient:</b> Steep</p> <p><b>Valley form:</b> Shallow vee</p> <p><b>Bank condition:</b> Stable</p> <p><b>Bed material:</b> Boulders, Coarse gravel, Vegetation, Soil</p> <p><b>Riparian corridor:</b> Commercial forestry</p> <p><b>Flow condition:</b> Fast</p> <p><b>Culvert Dimensions (m):</b></p> <ul style="list-style-type: none"><li>- Height (m): 0.50</li><li>- Outside Width (m): 0.50</li></ul> <p><b>Water width (m):</b> 0.40</p> <p><b>Water depth (m):</b> 0.50</p> <p><b>Bankfull width (m):</b> 0.40</p> <p><b>Bankfull height (m):</b> 0.50</p> <p><b>Banktop height (m):</b> 0.50</p> <p><b>Flooded Bankfull width (m):</b> 1.00</p> <p><b>Flooded Bankfull height:</b> 0.50</p> <p><b>Note:</b> During the survey, the river was in full spate following recent heavy rainfall. Water emerging from the culvert dispersed laterally across the land; however, further downslope the flow converged and re-formed into a more defined channel.</p> | |

| ID | Easting | Northing | Existing Crossing? | Potential Crossing Type and Considerations | Potential EASR Authorisation Level |
|---|---|---|---|---|---|
| WX6 | 175580 | 644851 | Yes; existing circular culvert | Maintain if possible. If track/embankment require significant works, consider replacement with an oversized embedded culvert or bottomless arch culvert. | Registration |

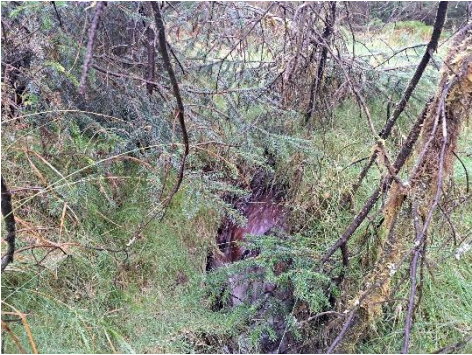
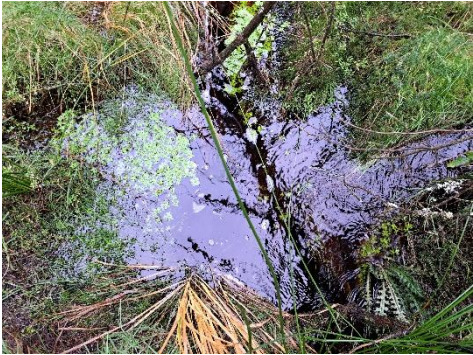
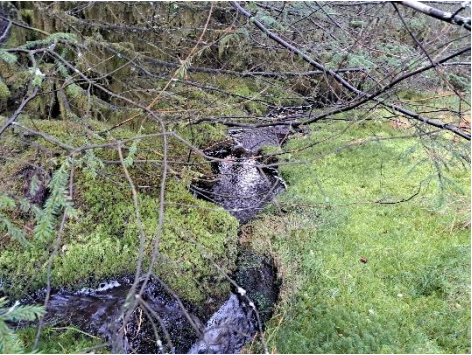
| WX7 (175813, 643903) | | |
|---|---|--|
| | <p><b>Existing Crossing:</b> No</p> <p><b>Channel Type:</b> Poorly Defined</p> <p><b>Gradient:</b> Moderate</p> <p><b>Valley form:</b> No obvious valley sides</p> <p><b>Bank condition:</b> Undercut (no evidence of recent collapse)</p> <p><b>Bed material:</b> Bedrock, Peat, Rounded pebbles</p> <p><b>Riparian corridor:</b> Commercial forestry</p> <p><b>Flow condition:</b> Moderate</p> <p><b>Water width (m):</b> 0.50</p> <p><b>Water depth (m):</b> 0.40</p> <p><b>Bankfull width (m):</b> 0.50</p> <p><b>Bankfull height (m):</b> 0.50</p> <p><b>Banktop height (m):</b> 0.50</p> <p><b>Flooded Bankfull width (m):</b> 1.55</p> <p><b>Flooded Bankfull height:</b> 0.55</p> <p><b>Note:</b> Water flow is not fully contained within a channel. Water direction and flow direction clearer/more defined upstream and downstream of sample point.</p> | |

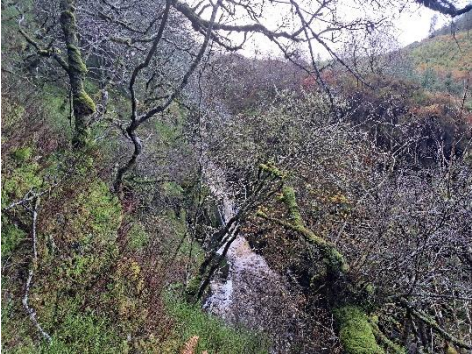
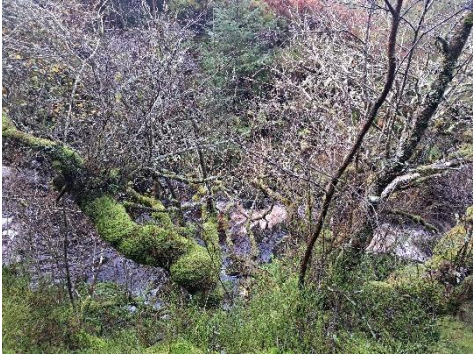
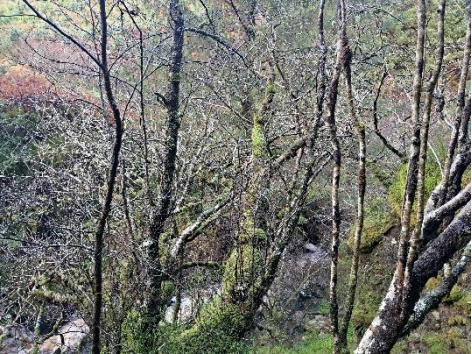
\*It is noted that during the site visit the watercourse corresponding to WX8 was not accessed due to safety concerns relating to a steep gorge.

| WX8 (176048, 645197) | | |
|---|---|--|
| | <p><b>Existing Crossing:</b> No</p> <p><b>Channel Type:</b> Incised</p> <p><b>Gradient:</b> Steep</p> <p><b>Valley form:</b> Gorge</p> <p><b>Bank condition:</b> Undercut (no evidence of recent collapse)</p> <p><b>Bed material:</b> Boulders, Coarse gravel, Rounded pebbles, Bedrock</p> <p><b>Riparian corridor:</b> Commercial forestry</p> <p><b>Flow condition:</b> Very Fast</p> <p><b>Water width (m):</b> Unable to obtain measurement</p> <p><b>Water depth (m):</b> Unable to obtain measurement</p> <p><b>Bankfull width (m):</b> Unable to obtain measurement</p> <p><b>Bankfull height (m):</b> Unable to obtain measurement</p> <p><b>Banktop height (m):</b> Unable to obtain measurement</p> <p><b>Flooded Bankfull width (m):</b> Unable to obtain measurement</p> <p><b>Flooded Bankfull height:</b> Unable to obtain measurement</p> <p><b>Note:</b> The watercourse could not be accessed due to steep banks and associated safety concerns.</p> | |

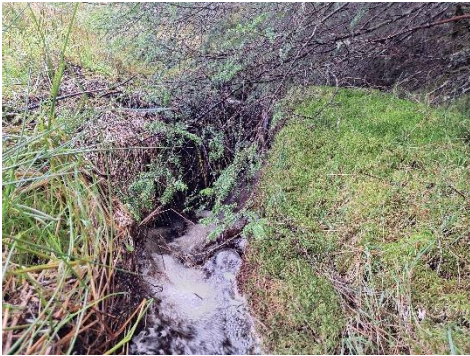
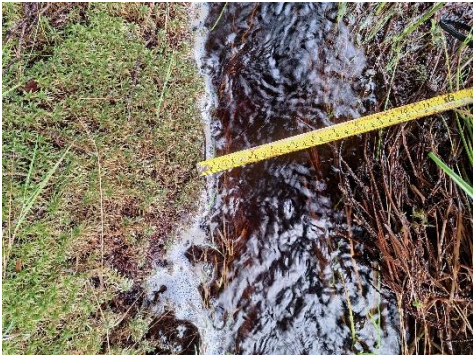
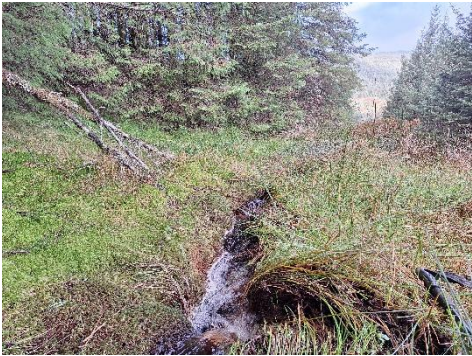
Crossing Photographs

**Existing Crossing:** No  
**Channel Type:** Incised  
**Gradient:** Steep  
**Valley form:** Deep Vee  
**Bank condition:** Stable  
**Bed material:** Soil, Vegetation, Peat, Rounded pebbles  
**Riparian corridor:** Commercial forestry  
**Flow condition:** Fast

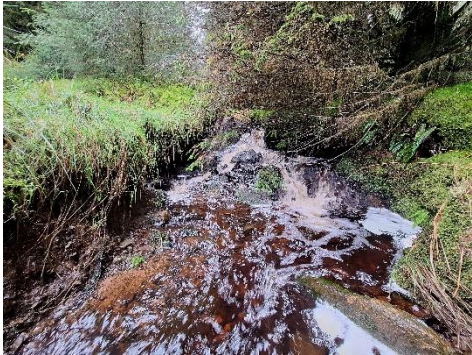
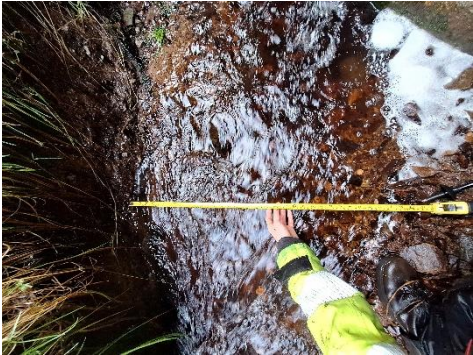
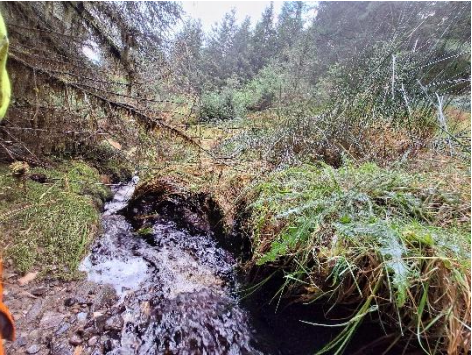
| WX16 (176956, 644612) | | |
|---|---|---|
| <p>© Crown Copyright 2025. All rights reserved. Ordnance Survey Licence 0100031673.</p> | <b>Existing Crossing:</b> No | <b>Water width (m):</b> 0.87 |
| | <b>Channel Type:</b> Incised | <b>Water depth (m):</b> 0.09 |
| | <b>Gradient:</b> Moderate | <b>Bankfull width (m):</b> 0.87 |
| | <b>Bank condition:</b> Stable | <b>Banktop height (m):</b> 0.54 |
| | <b>Flow condition:</b> Fast | <b>Note:</b> A waterfall is located upstream of the crossing point. |

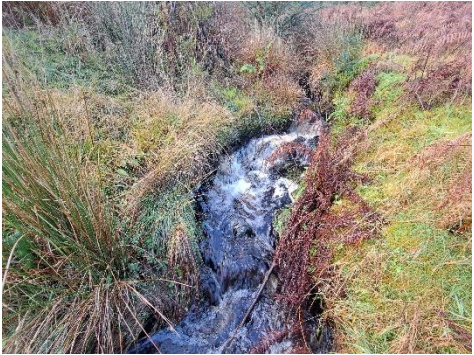
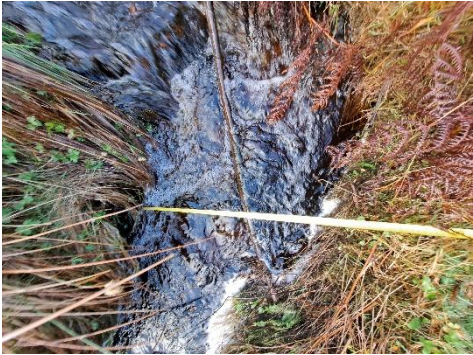
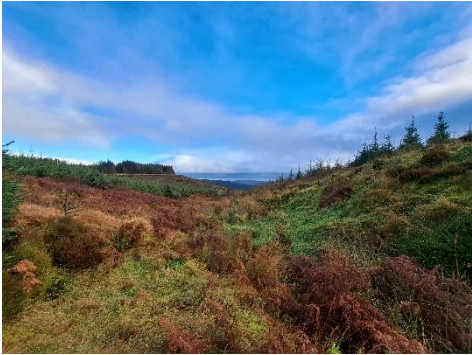
| WX17 (177004, 643755) | | |
|---|---|---|
| <p>© Crown Copyright 2025. All rights reserved. Ordnance Survey Licence 0100031673.</p> | <p><b>Existing Crossing:</b> No</p> <p><b>Channel Type:</b> Incised</p> <p><b>Gradient:</b> Steep</p> <p><b>Valley form:</b> Deep Vee</p> <p><b>Bank condition:</b> Undercut (no evidence of recent collapse)</p> <p><b>Bed material:</b> Boulders, Rounded pebbles, Coarse gravel</p> <p><b>Riparian corridor:</b> Commercial forestry</p> <p><b>Flow condition:</b> Moderate</p> | <p><b>Water width (m):</b> 0.75</p> <p><b>Water depth (m):</b> 0.20</p> <p><b>Bankfull width (m):</b> 0.75</p> <p><b>Bankfull height (m):</b> 0.20</p> <p><b>Banktop height (m):</b> 0.75</p> <p><b>Flooded Bankfull width (m):</b> 1.25</p> <p><b>Flooded Bankfull height:</b> 0.75</p> <p><b>Note:</b> None</p> |

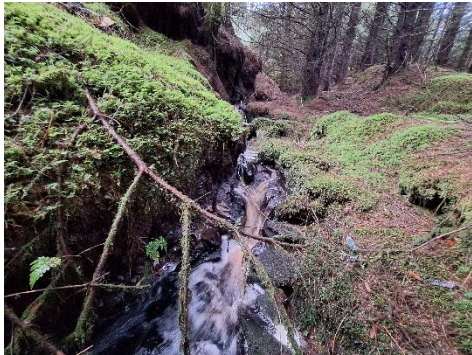
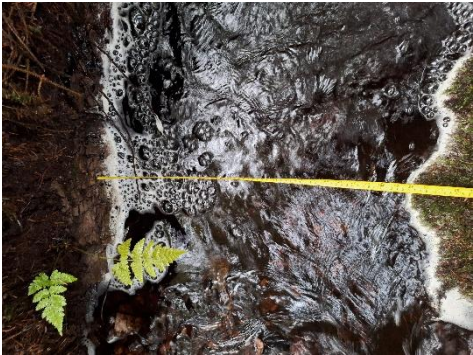
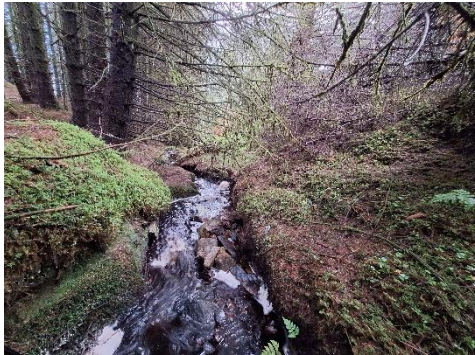
WX18 (177053, 645435)

**Existing Crossing:** No  
**Channel Type:** Incised  
**Gradient:** Moderate  
**Valley form:** Gorge  
**Bank condition:** Stable  
**Bed material:** Boulders, Rounded pebbles, Coarse gravel  
**Riparian corridor:** Commercial forestry  
**Flow condition:** Moderate

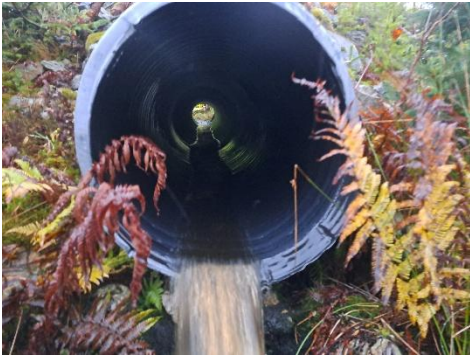
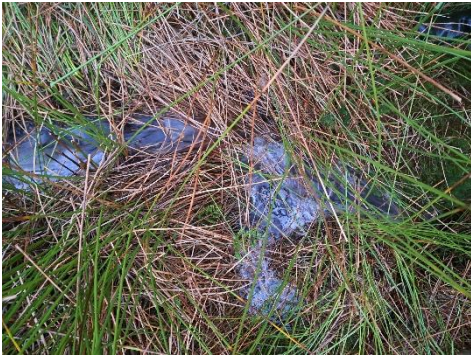
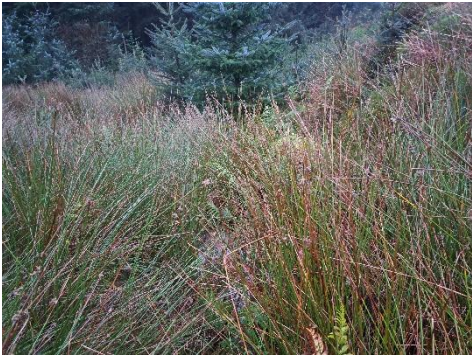
| WX19 (175247, 644591) | | |
|---|---|--|
| | <p><b>Existing Crossing:</b> Yes</p> <p><b>Crossing Type (existing):</b> Circular Culvert</p> <p><b>Crossing Material (existing):</b> Plastic</p> <p><b>Crossing Condition (existing):</b> Average</p> <p><b>Channel Type:</b> Incised</p> <p><b>Gradient:</b> Steep</p> <p><b>Valley form:</b> Deep Vee</p> <p><b>Bank condition:</b> Stable</p> <p><b>Bed material:</b> Rounded pebbles, Boulders, Vegetation, Soil</p> <p><b>Riparian corridor:</b> Commercial forestry</p> <p><b>Flow condition:</b> Moderate</p> <p><b>Culvert Dimensions (m):</b></p> <ul style="list-style-type: none"><li>- Height (m): 0.65</li><li>- Outside Width (m): 0.65</li></ul> <p><b>Water width (m):</b> 0.27</p> <p><b>Water depth (m):</b> 0.20</p> <p><b>Bankfull width (m):</b> 0.27</p> <p><b>Bankfull height (m):</b> 0.20</p> <p><b>Banktop height (m):</b> 0.27</p> <p><b>Flooded Bankfull width (m):</b> 0.55</p> <p><b>Flooded Bankfull height:</b> 0.28</p> <p><b>Note:</b> Additional crossing observed during survey.</p> | |

- It is also recommended that existing culverts be subject to maintenance works to reduce overgrowth and/or potential sources of blockage which could potentially restrict flow through them in the future.

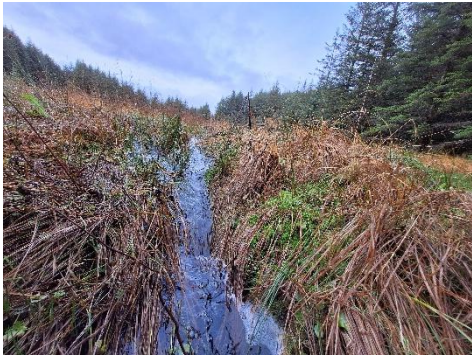
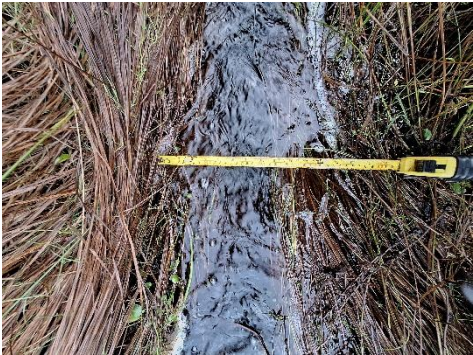
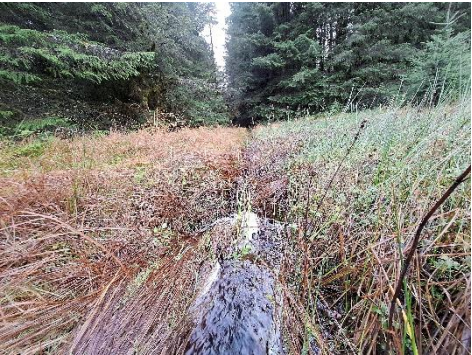
| IN1 (174812, 643136) | | |

| IN1 (174812, 643136) | | |
|---|---|---|
| <p>© Crown Copyright 2025. All rights reserved. Ordnance Survey Licence 0100031673.</p> | <b>Channel Type:</b> Surface run-off/wetlands only | |
| | <b>Gradient:</b> Gentle | |
| | <b>Valley form:</b> Concave bowl | |
| | <b>Bank condition:</b> Stable | |
| <b>Flow condition:</b> Moderate | | <b>Water depth (m):</b> 0.53 |

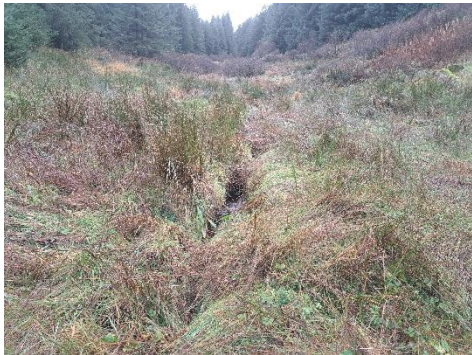
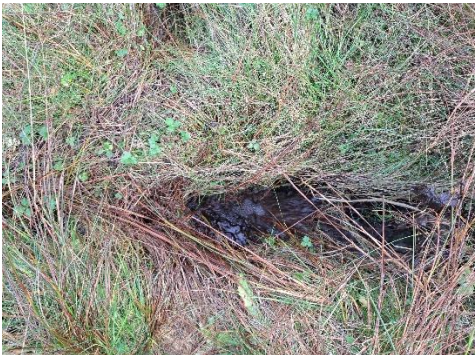
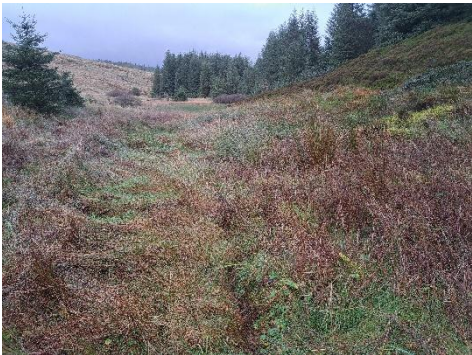
IN2 (174853, 643461)

**Channel Type:** Incised  
**Gradient:** Moderate  
**Valley form:** U-shaped valley  
**Bank condition:** Undercut (no evidence of recent collapse)  
**Bed material:** Peat, Soil, Vegetation, Fine sand/silt  
**Riparian corridor:** Commercial forestry  
**Flow condition:** Fast

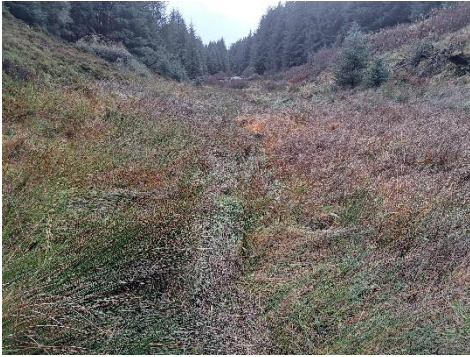
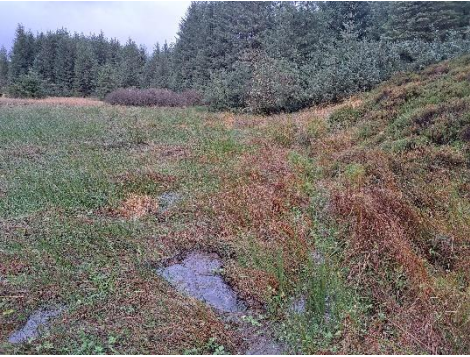
| IN3 (174895, 643528) | | |
|---|---|--|
| <p>© Crown Copyright 2025. All rights reserved. Ordnance Survey Licence 0100031673.</p> | <p><b>Channel Type:</b> Surface run-off/wetlands only</p> <p><b>Gradient:</b> Gentle</p> <p><b>Valley form:</b> U-shaped valley</p> <p><b>Bank condition:</b> Stable</p> <p><b>Bed material:</b> Vegetation</p> <p><b>Riparian corridor:</b> Commercial forestry</p> <p><b>Flow condition:</b> Very Slow</p> <p><b>Water width (m):</b> N/a</p> <p><b>Water depth (m):</b> N/a</p> <p><b>Bankfull width (m):</b> N/a</p> <p><b>Bankfull height (m):</b> N/a</p> <p><b>Banktop height (m):</b> N/a</p> <p><b>Flooded Bankfull width (m):</b> N/a</p> <p><b>Flooded Bankfull height:</b> N/a</p> <p><b>Note:</b> The channel lacks clear definition, with water dispersing across the valley floor. The incursion area is predominantly a rush-dominated wetland habitat.</p> | |

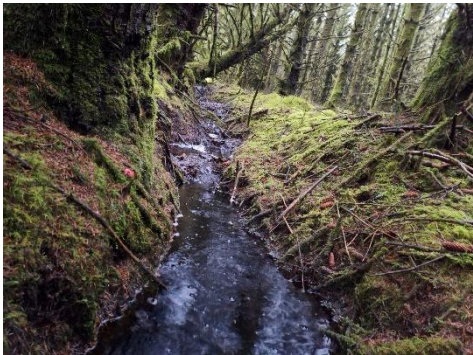
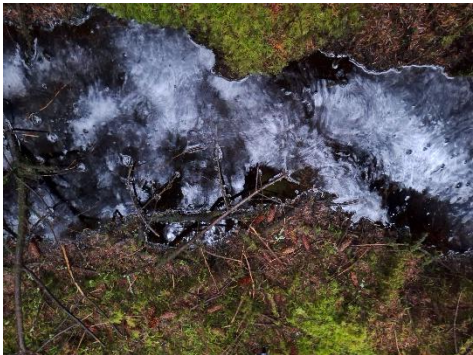
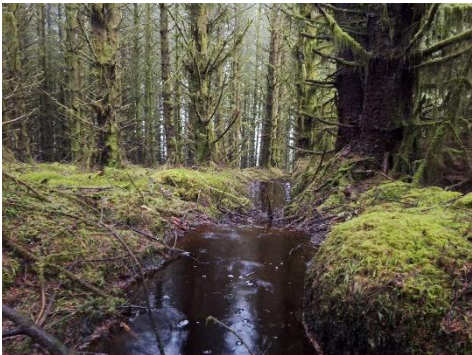
| IN5 (175256, 644735) | | |

| IN5 (175256, 644735) | | |
|---|---|---|
| <p>© Crown Copyright 2025. All rights reserved. Ordnance Survey Licence 0100031673.</p> | <b>Channel Type:</b> Artificial drainage channel | <b>Water width (m):</b> 0.65 |
| | <b>Gradient:</b> Moderate | <b>Water depth (m):</b> 0.25 |
| | <b>Valley form:</b> No obvious valley sides | <b>Bankfull width (m):</b> 0.65 |
| | <b>Bank condition:</b> Stable | <b>Bankfull height (m):</b> 0.25 |
| | <b>Flow condition:</b> Moderate | <b>Flooded Bankfull height:</b> 0.35 |

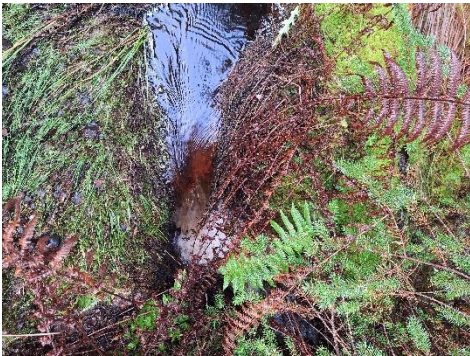
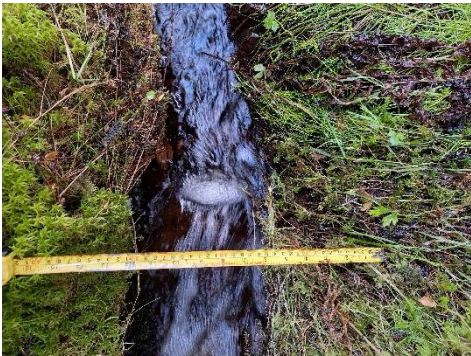
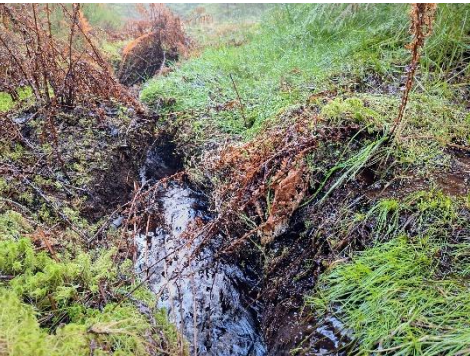
| IN10 (176431, 645522) | | |

| IN10 (176431, 645522) | | |
|---|---|---|
| <p>© Crown Copyright 2025. All rights reserved. Ordnance Survey Licence 0100031673.</p> | <b>Channel Type:</b> Meandering | <b>Water width (m):</b> 0.40 |
| | <b>Gradient:</b> Moderate | <b>Water depth (m):</b> 0.10 |
| | <b>Valley form:</b> No obvious valley sides | <b>Bankfull width (m):</b> 0.40 |
| | <b>Bank condition:</b> Stable | <b>Bankfull height (m):</b> 0.10 |
| | <b>Flow condition:</b> Fast. | <b>Flooded Bankfull height:</b> 0.25 |

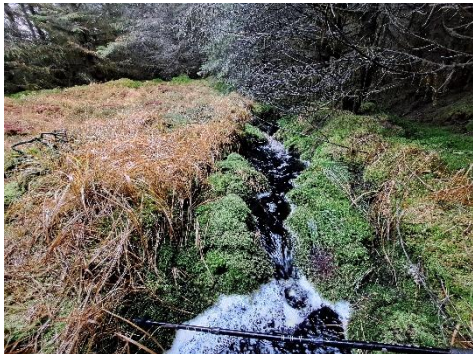
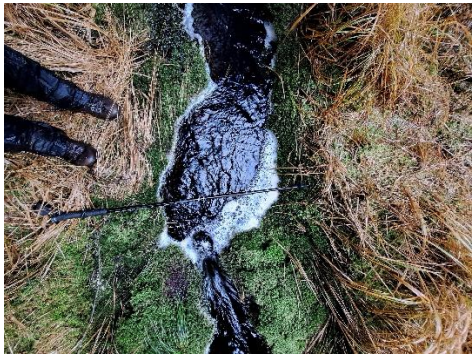
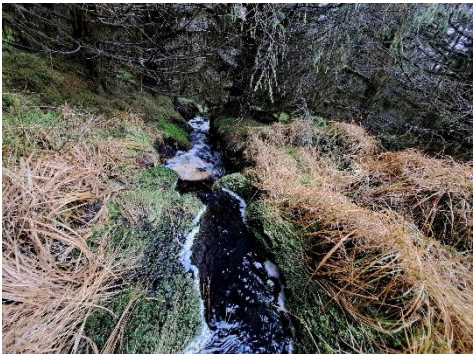
| IN11 (177099, 644368) | |
|---|---|
| <p>© Crown Copyright 2025. All rights reserved. Ordnance Survey Licence 0100031673.</p> | <p><b>Channel Type:</b> Artificially modified watercourse</p> <p><b>Gradient:</b> Moderate</p> <p><b>Valley form:</b> No obvious valley sides</p> <p><b>Bank condition:</b> Undercut (no evidence of recent collapse)</p> <p><b>Bed material:</b> Peat, Rounded pebbles, Coarse gravel</p> <p><b>Riparian corridor:</b> Commercial forestry</p> <p><b>Flow condition:</b> Fast</p> |
| | <p><b>Water width (m):</b> 0.60</p> <p><b>Water depth (m):</b> 0.45</p> <p><b>Bankfull width (m):</b> 0.60</p> <p><b>Bankfull height (m):</b> 0.45</p> <p><b>Banktop height (m):</b> 0.60</p> <p><b>Flooded Bankfull width (m):</b> 1.10</p> <p><b>Flooded Bankfull height:</b> 0.70</p> <p><b>Note:</b> None</p> |
